# Manhole Inspection Summary

Manhole # S13E\_\_008MH

**Inspection** ☐ Is Incomplete Rating: **4) Poor**

**Location** Address: **2801 MULBERRY ST**

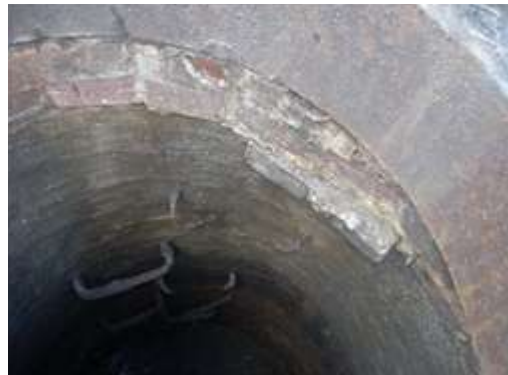
Defect 4

Count: **3** Missing: **2** ☒ **Corroded**

CORRODED AND MISSING STEPS

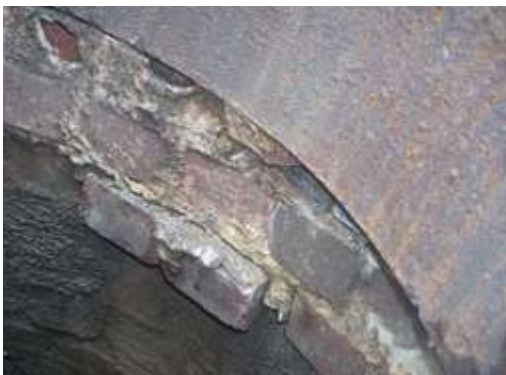
Defect 1

Condition: ☐ Sound ☐ Cracked ☐ Root Intrusion ☒ **Loose Brick** ☒ **Deteriorated**

LOOSE CHIMNEY BRICKS

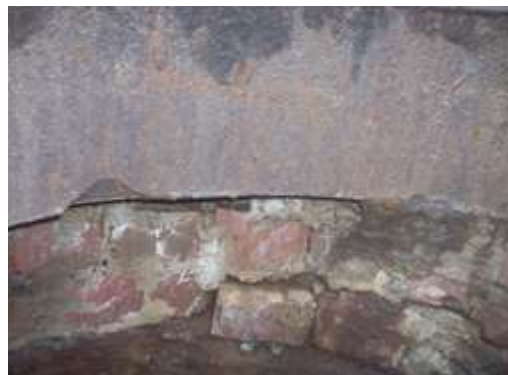
Defect 2

DETERIORATED CHIMNEY

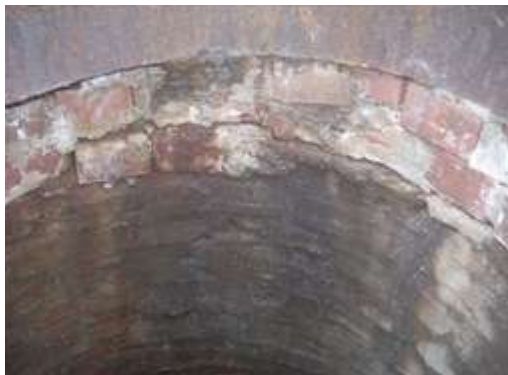
### Defect 3

Infiltration: ☐ None ☒ **Joint** ☐ Cracks ☐ Mortar ☐ Roots ☐ Wall

INFILTRATION OF CORBEL JOINT

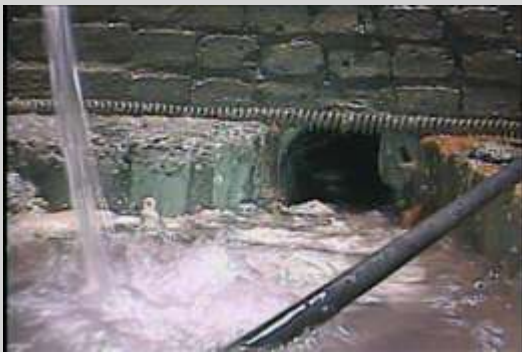
12 O'Clock Outflow

Pipe Height: **7.2** (in.) Rod and Bar (Angled)  
Pipe Material: **Clay** ☐ Pipe Lined  
Invert Depth: **10.52** (ft.) Flow Characteristics: **Slow**  
Deposits: ☐ None ☐ Mud ☐ Sludge ☒ **Debris** ☐ Grease  
Silt Depth: **1** (in.) Deposits Extent: **Light**  
Infiltration: **None** Pipe Seal Cond: **Sound**

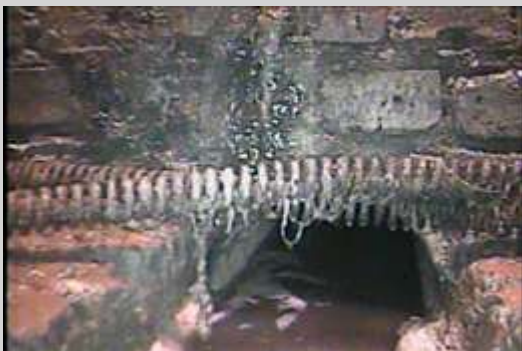
6 O'Clock Inflow

Pipe Height: **8.4** (in.) Rod and Bar (Angled)  
Pipe Material: **Clay** ☐ Pipe Lined  
Invert Depth: **10.47** (ft.) Flow Characteristics: **Slow**  
Deposits: ☐ None ☐ Mud ☐ Sludge ☒ **Debris** ☐ Grease  
Silt Depth: **2** (in.) Deposits Extent: **Light**  
Infiltration: **None** Pipe Seal Cond: **Sound**

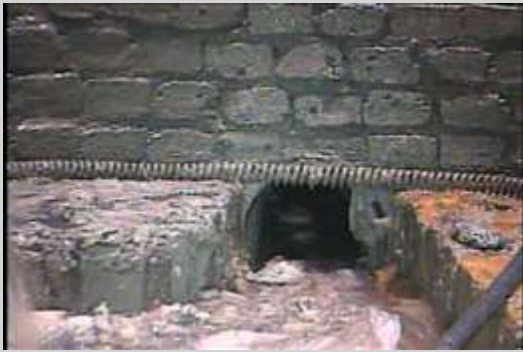
7 O'Clock Inflow

Deposits: ☐ None ☐ Mud ☐ Sludge ☒ **Debris** ☐ Grease

Silt Depth: **5** (in.) Deposits Extent: **Heavy**

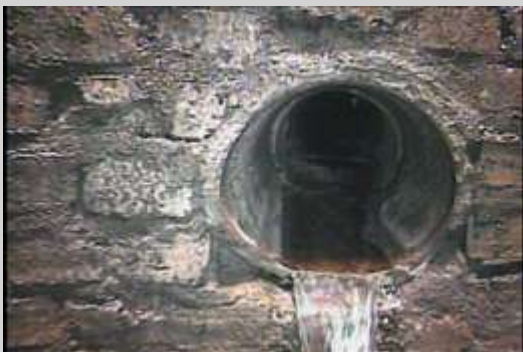
10 O'Clock Inflow

LOOSE CHIMNEY BRICKS

Deposits: ☐ None ☐ Mud ☐ Sludge ☒ **Debris** ☐ Grease

Silt Depth: **7** (in.) Deposits Extent: **Heavy**

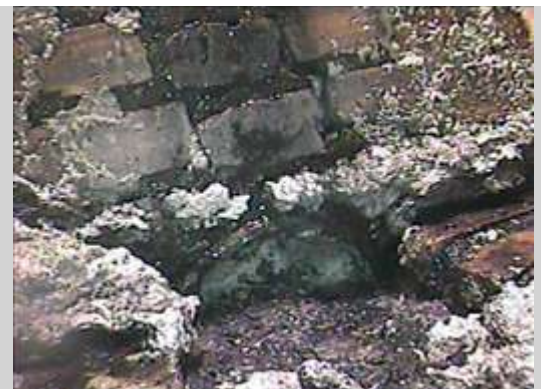
Drop In @ 10 O'Clock

LOOSE CHIMNEY BRICKS

Drop Condition: **Clogged**
